# SS Thistlegorm Past & Present

by Mark Webster

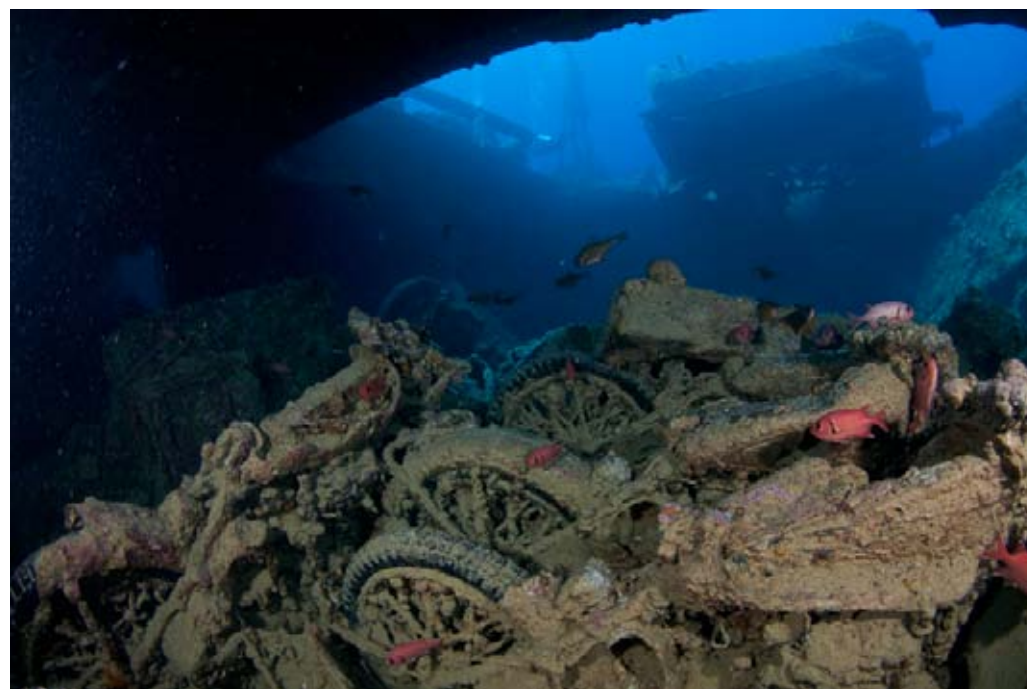
*(Right) Thistlegorm 2011 – part of the cargo of motor cycles in #1 hold. In the background can be seen the rolling stock bowser on the port side forward deck which is beginning to sag and fail. Nikon D300, Subal ND2, 10-17mm FE zoom, Inon Z240 flash guns, ISO 200 f8 1/30*

Outside on the forward decks there are items of rolling stock which are also bereft of marine life now. The deck under the bowser adjacent to No.1 hold on the port side is now sagging and it may not be long before this falls into the hold. Crossing over the collapsed section of the wreck on the way to the stern you will find more of the cargo including the armoured tracked vehicles which are again a feature for a diver image. At the mid section it is worth swimming off the wreck on the port side to visit the steam locomotive which remains mostly untouched. When you reach the stern the main attraction is the 4.7 inch gun, which hopefully will not continue to be used as a convenient

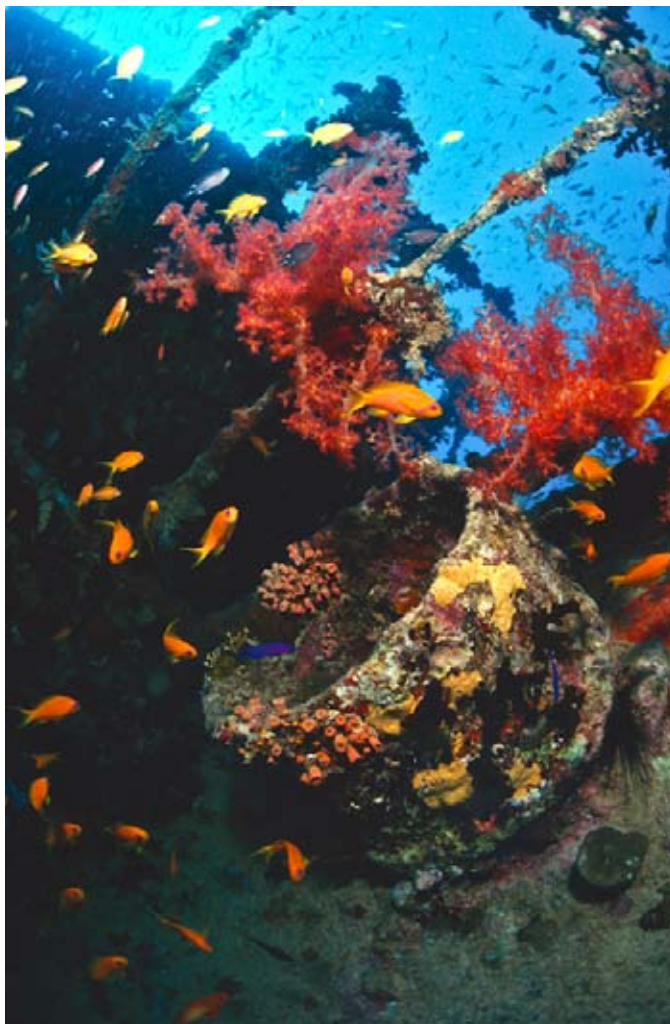
*Thistlegorm starboard side walkway aft of bridge 1995 – healthy colonies of soft corals covered the wreck during this period. Nikon 801, Subal housing, 16mm FE, Subatec S100, Ektachrome 100, f8 1/60*

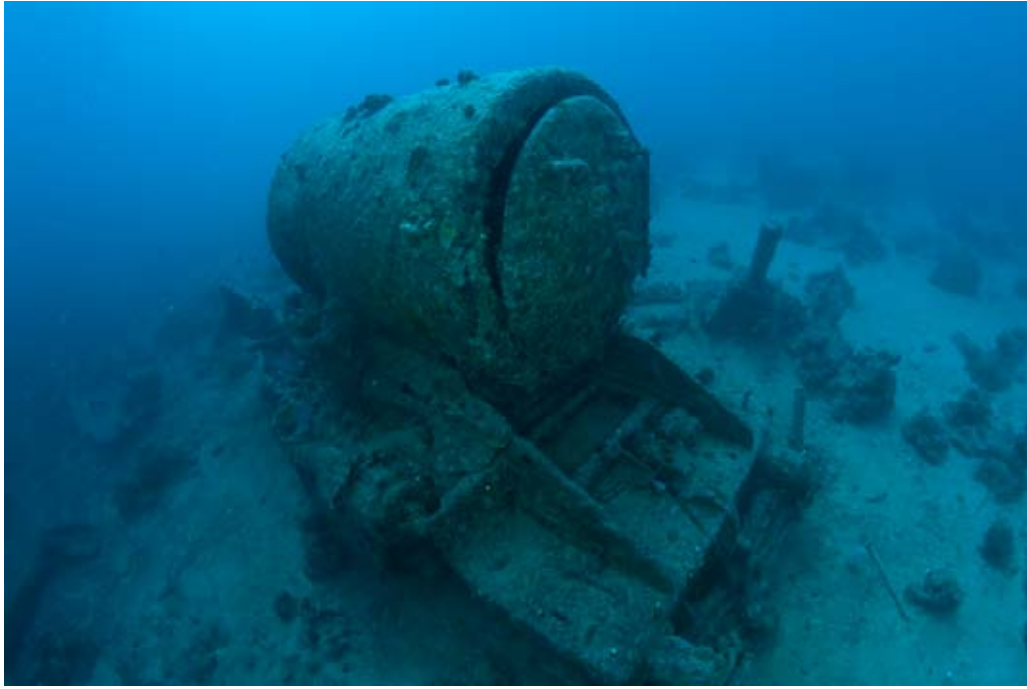
*Thistlegorm 2011 – on the port side adjacent to the collapsed mid section of the wreck lies the remains of one of the locomotives. This is one of the deepest areas of the wreck to visit, but worth a few minutes to capture some images. Nikon D300, Subal ND2, 10-17mm FE zoom, Inon Z240 flash guns, ISO 200 f8 1/30*

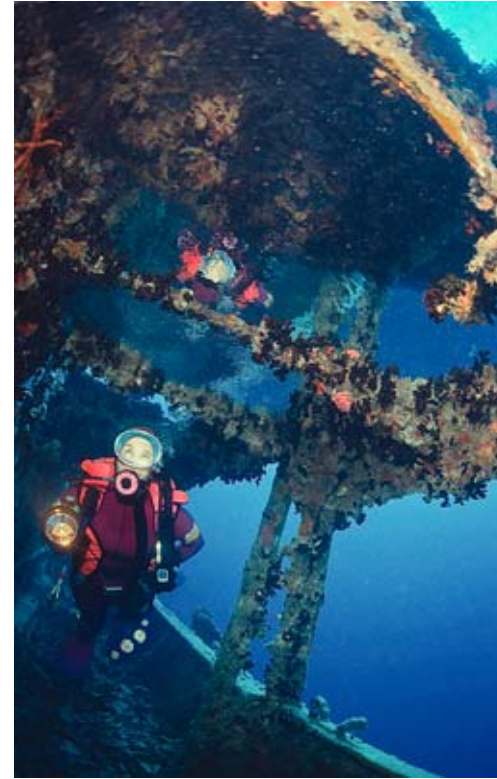
*Thistlegorm forward port walkway 1993 – this was the first year that dive boats began to visit the wreck regularly, although the numbers were very small. Coral growth remained healthy although there are already large amounts of expired air trapped. Nikon 801, Subal housing, 16mm FE, Subatec S100, Ektachrome 100, f8 1/60.*

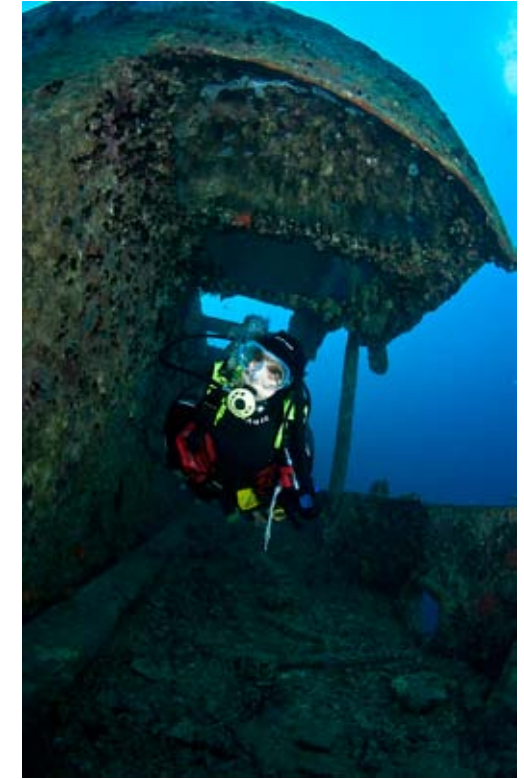
*Thistlegorm forward port walkway 2011 – the same location this year has very little coral growth left and stanchions have been torn away on the port gunwale by mooring lines. Nikon D300, Subal ND2, 10-17mm FE zoom, Inon Z240 flash guns, ISO 200 f11 1/80*

it is not uncommon to find up to twenty boats on location, all of them wanting to moor into the wreck or at least have a down line attached as the currents can be strong here. This has inevitably taken its toll and there are virtually no hand rails left and sections of the wreck have been torn away by thoughtless mooring. On my most recent visit there was even a boat moored to the stern gun,

so it is only a matter of time before that feature disappears as well. The huge volume of divers exploring the internal sections of the wreck has also accelerated corrosion due to the trapped air and nitrox which has led to the collapse of deck heads throughout the vessel. Couple this with the poaching of artefacts by trinket obsessed divers over the years means the continued destruction of the wreck
